A NOTCH BELOW

By Doug Walter

Double Whammy

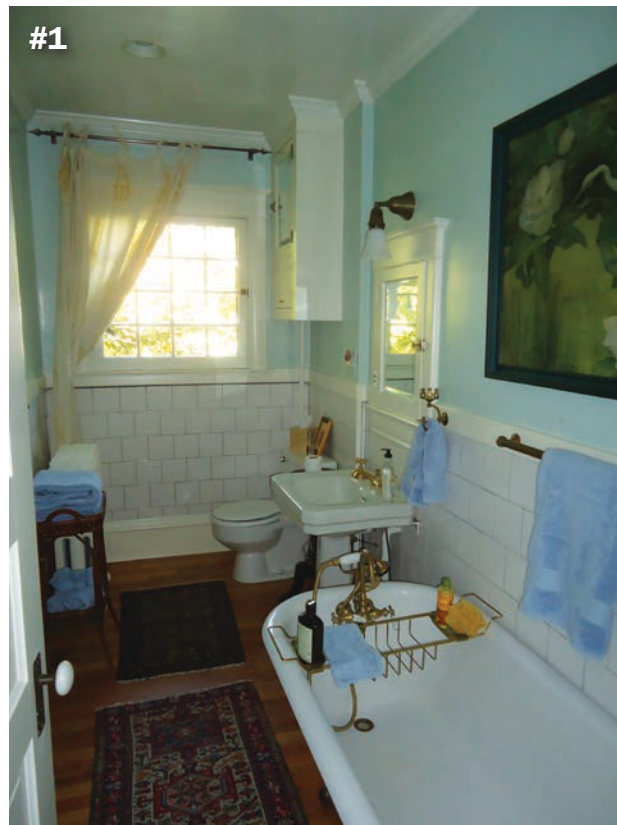
The bathroom pictured (**#1**) is in a lovely Denver Foursquare built in 1906 that had one remodel done, probably in the 1920's, judging by the fixtures. When that remodel happened, the drain location for the new tub was slightly different from the tub it replaced (which still resides in the backyard and is used as a planter). Working from above, the plumbers hacked about two-thirds of the way through the roughcut 2x10 joist, and also notched the bottom nearby to run wiring (**#2**). That left about 2 inches of useable cross section to carry the load. Leaking around the drain had eaten away another 10 inches along the top of the joist (**#3**).

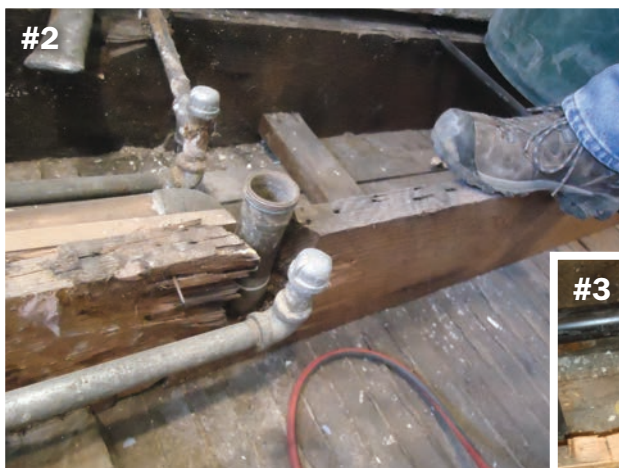
For years, this joist had been directly under a cast iron tub (weighing approximately 330 pounds) that regularly held 60 gallons of water (weighing 8.3 pounds per gallon, or 498 pounds), and a bather (say 200 pounds). Really, it was kind of a miracle that the tub and bather didn't end up in the dining room below!
